REPORT NUMBER 214-GTL-04-003

**SAFETY COMPLIANCE TESTING FOR  
FMVSS NO. 214S  
SIDE IMPACT PROTECTION (STATIC)**

**GENERAL MOTORS CORP.  
2004 CHEVROLET MALIBU, PASSENGER CAR  
NHTSA NO. C40102**

**FINAL REPORT**

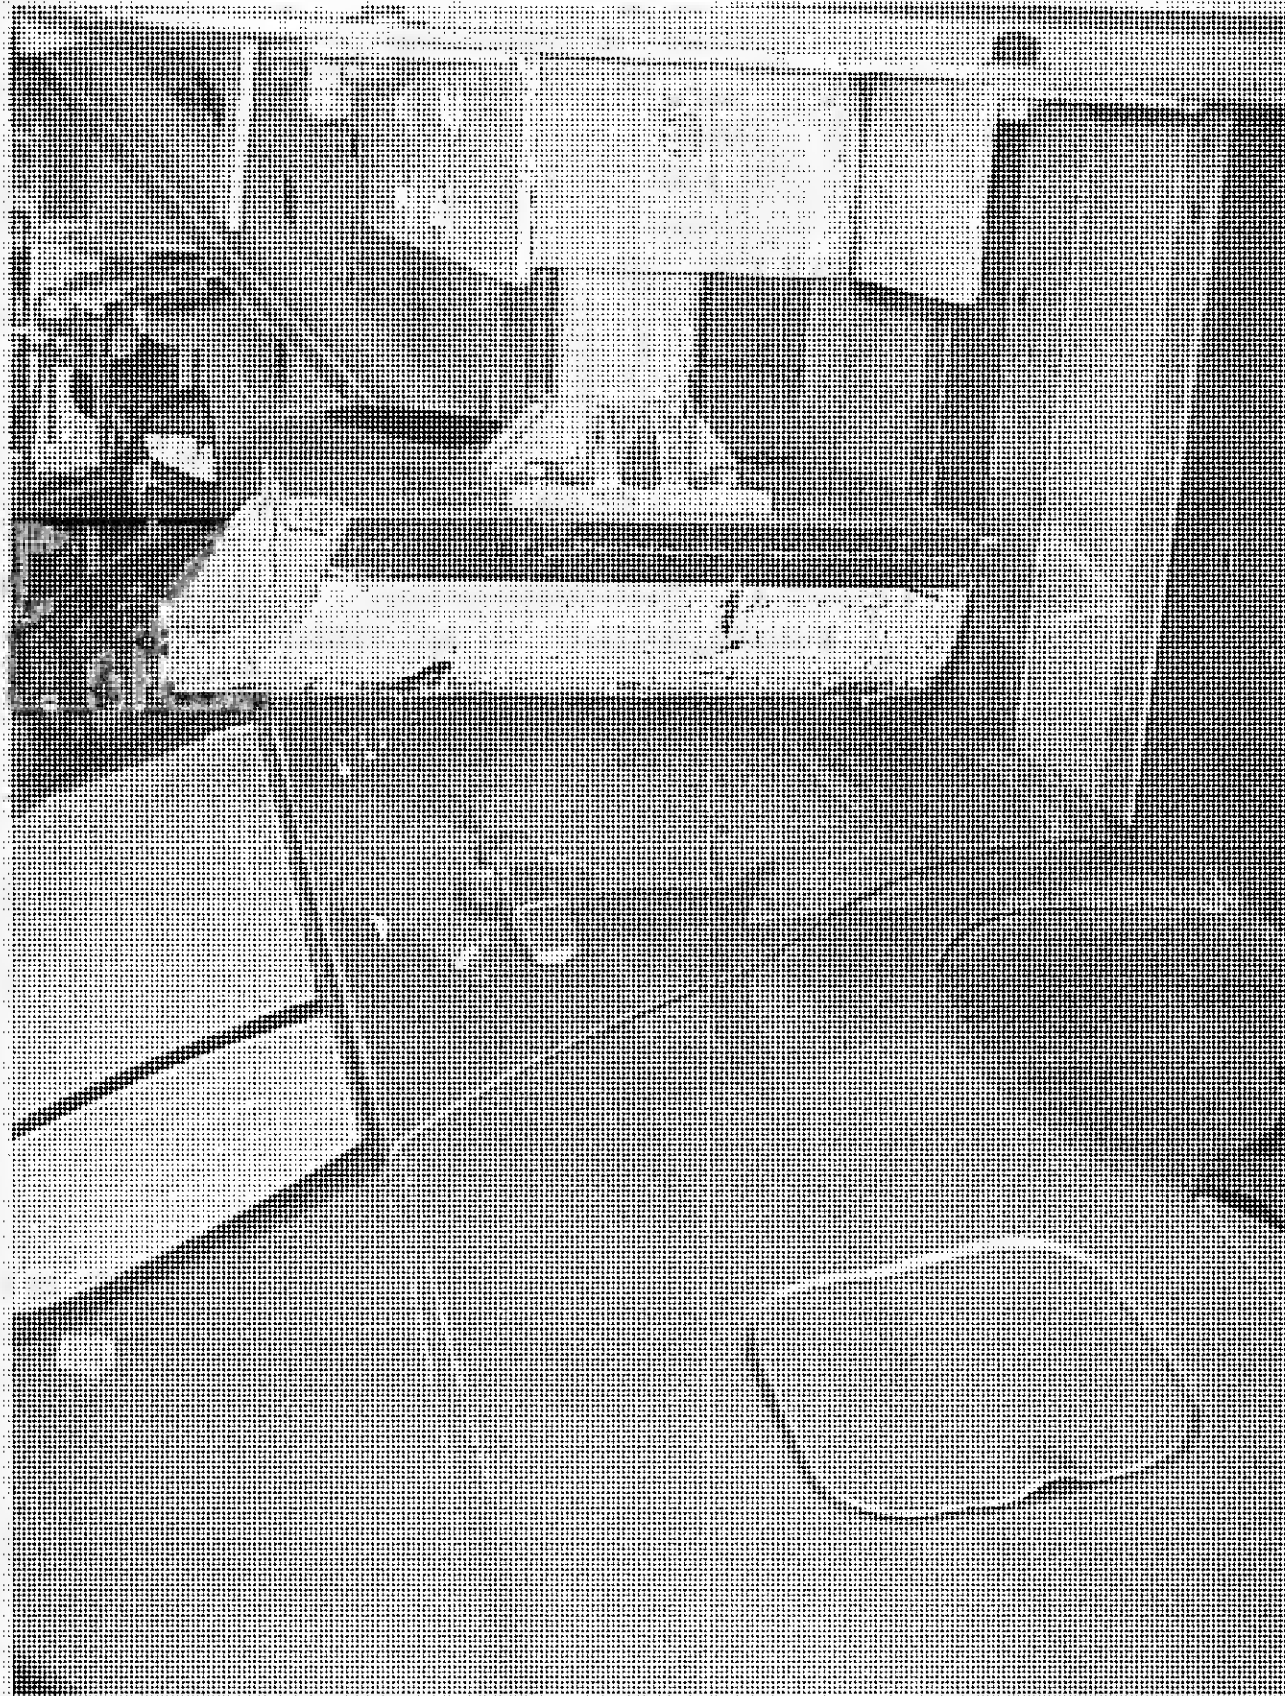
FIGURE 5.25  
LOAD DEVICE AGAINST DOOR - PRE-  
"TEST" 2

C.	Close all windows	<u>X</u>	<u>X</u>
D.	Lock All doors	<u>X</u>	<u>X</u>
E.	State door tested	<u>LF</u>	<u>RR</u>
F.	State the length of a horizontal line drawn on door through a point 5 inches vertically above lowest point of test door	<u>42.2</u>	<u>27.5</u>

G.	State vertical distance from the lowest part of test door to bottom of loading device	<u>5"</u>	<u>5"</u>
H.	State position of vertical centerline of loading device on the midpoint of line determined step F	<u>21.1</u>	<u>13.25</u>

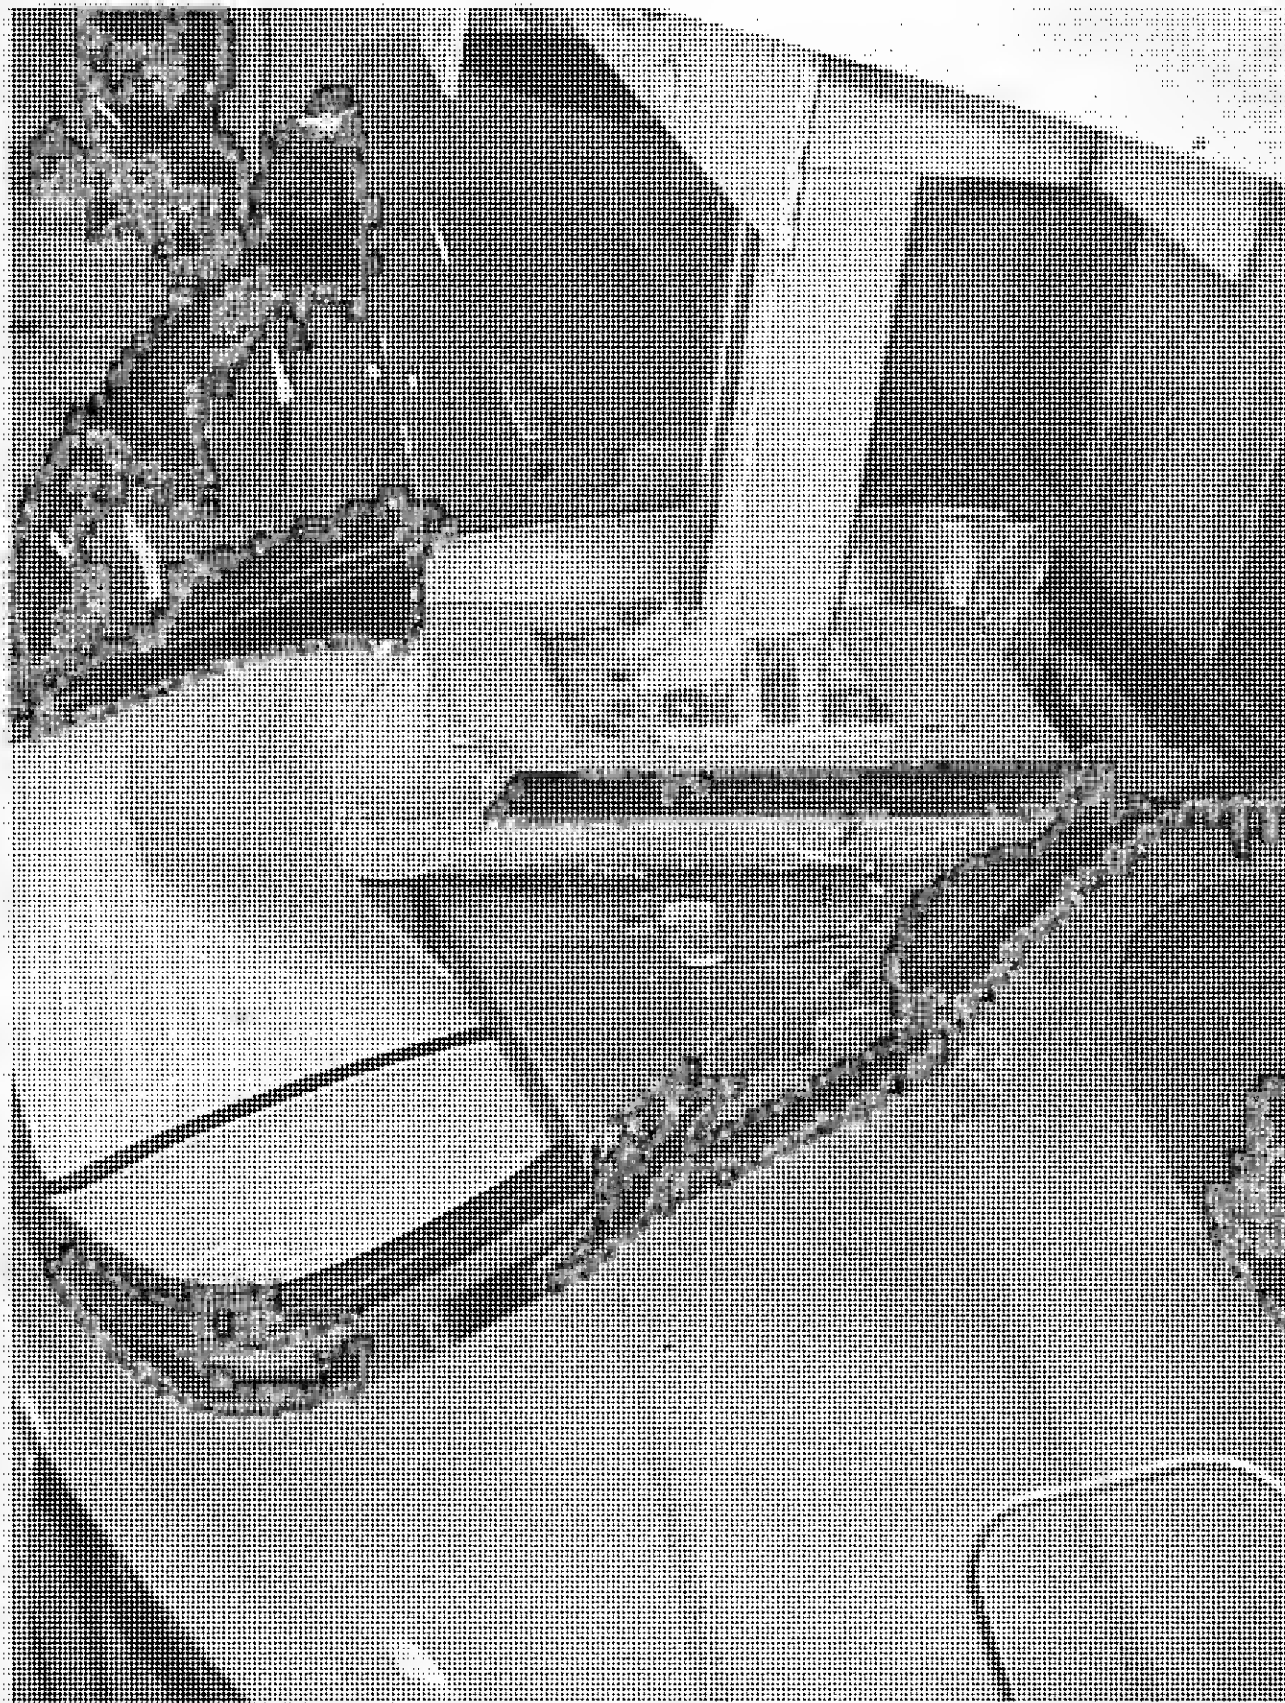
FIGURE 5.26  
LOAD DEVICE AGAINST DOOR @ MAX  
LOAD - TEST 2

- A. The initial crush resistance was 3674 lbs.  
 B. The intermediate crush resistance was 6211 lbs.  
 C. The peak crush resistance was 11,509 lbs at 12.761 inches  
 D. The rate of loading was .2"/sec

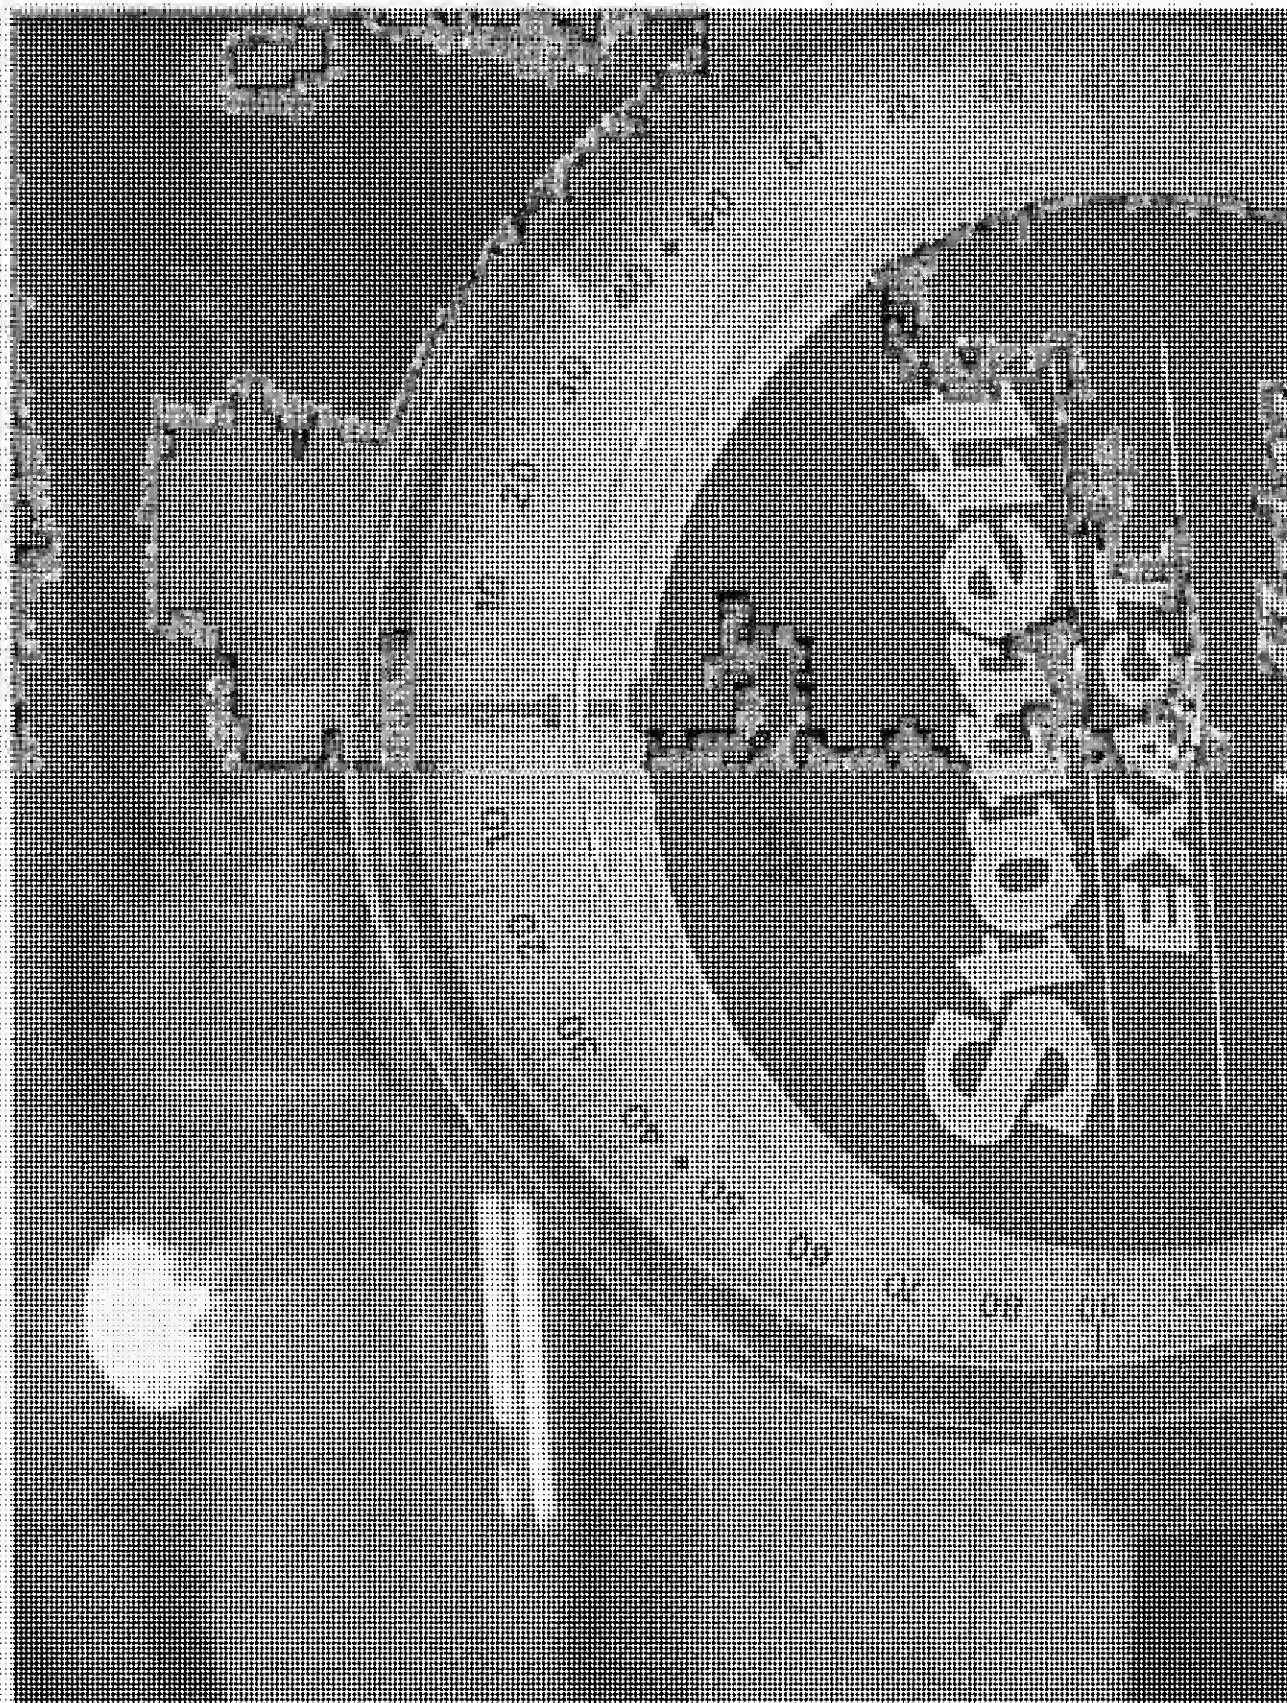
FIGURE 5.27  
INCLINOMETER AT MAX LOAD - TEST 2

LOADING DEVICE TRAVEL	DIAL INDICATOR	INCLINOMETER
0 inches	<u>0.0000</u>	<u>0</u>
2 inches	<u>0.0285</u>	<u>0</u>
4 inches	<u>0.0340</u>	<u>0</u>
6 inches	<u>0.0685</u>	<u>0</u>
12 inches	<u>0.4043</u>	<u>0</u>
<u>12.761</u> Inches (full travel)	<u>0.4043</u>	<u>0</u>

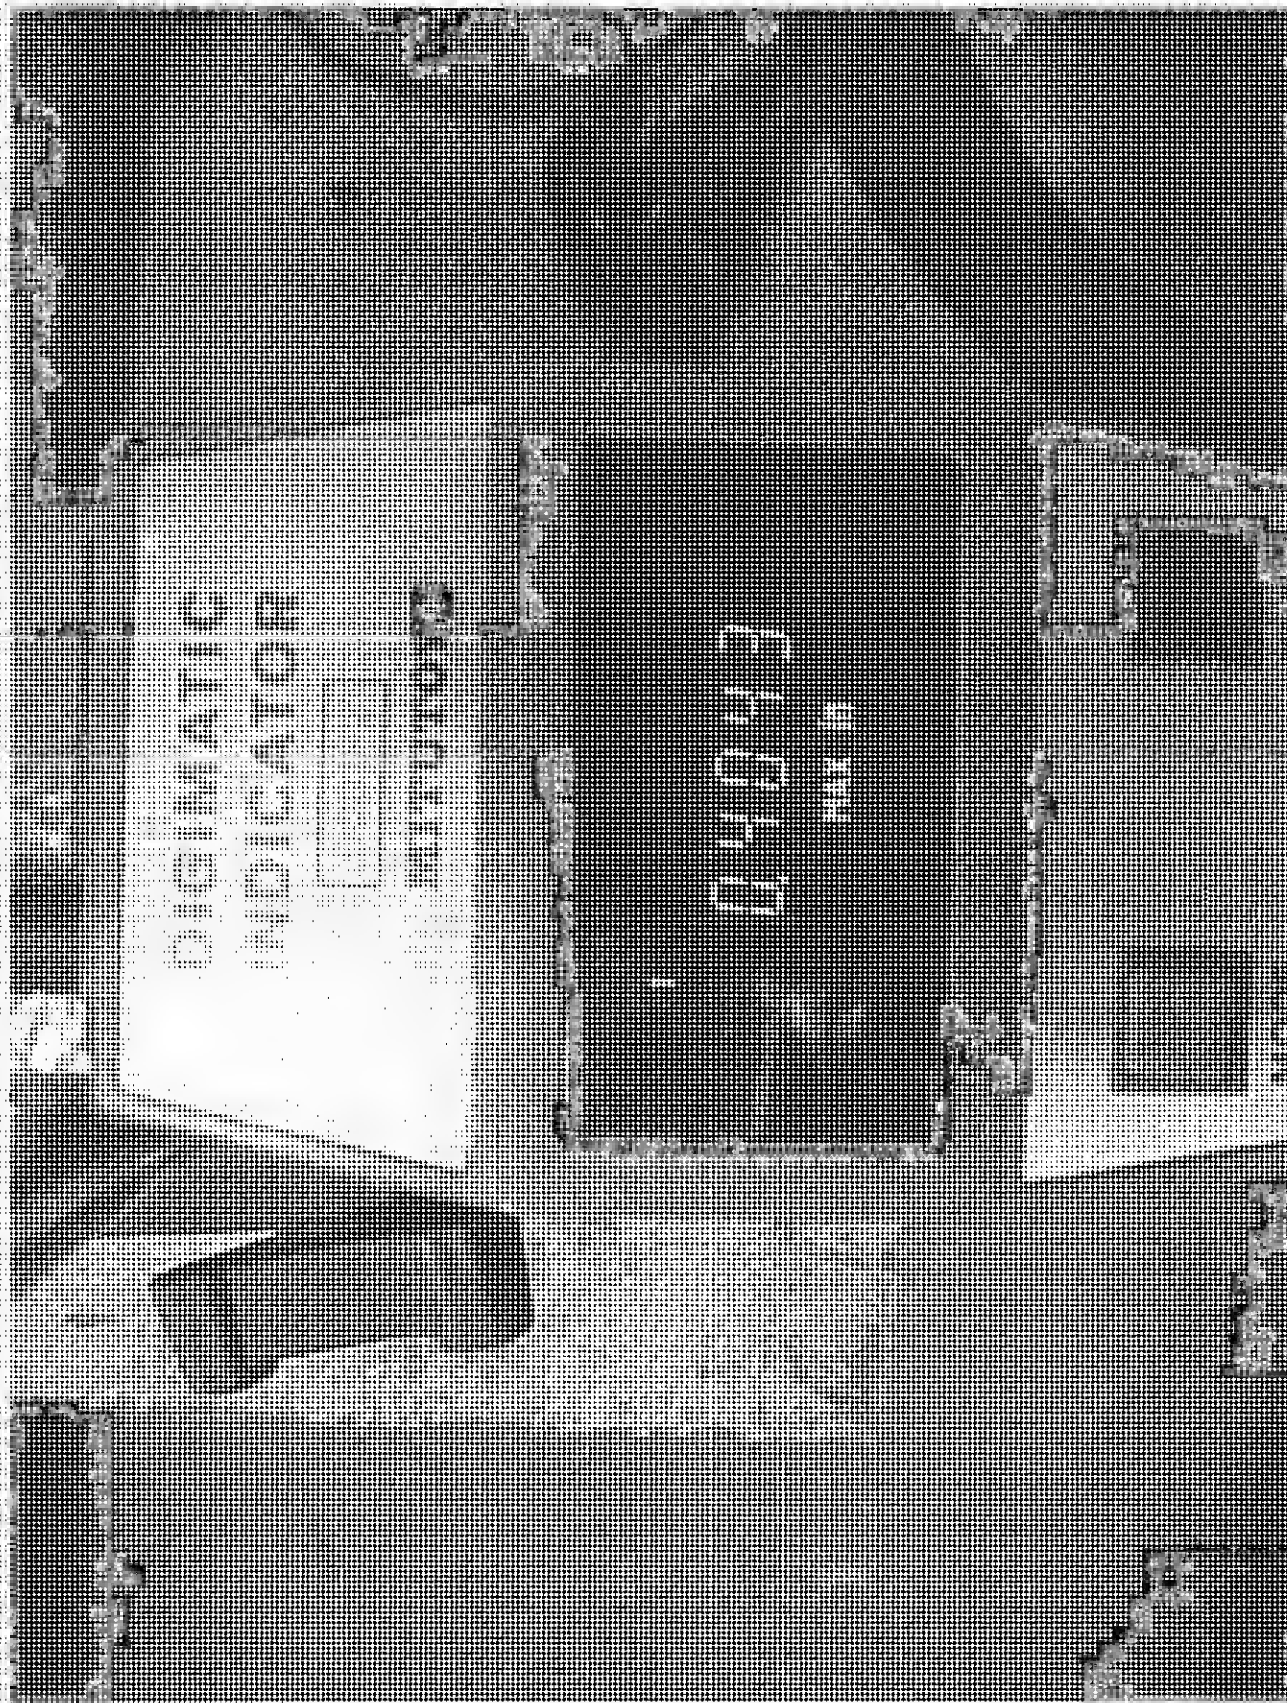
FIGURE 5.23  
FUEL INDICATOR AT MAX LOAD - TEST 2

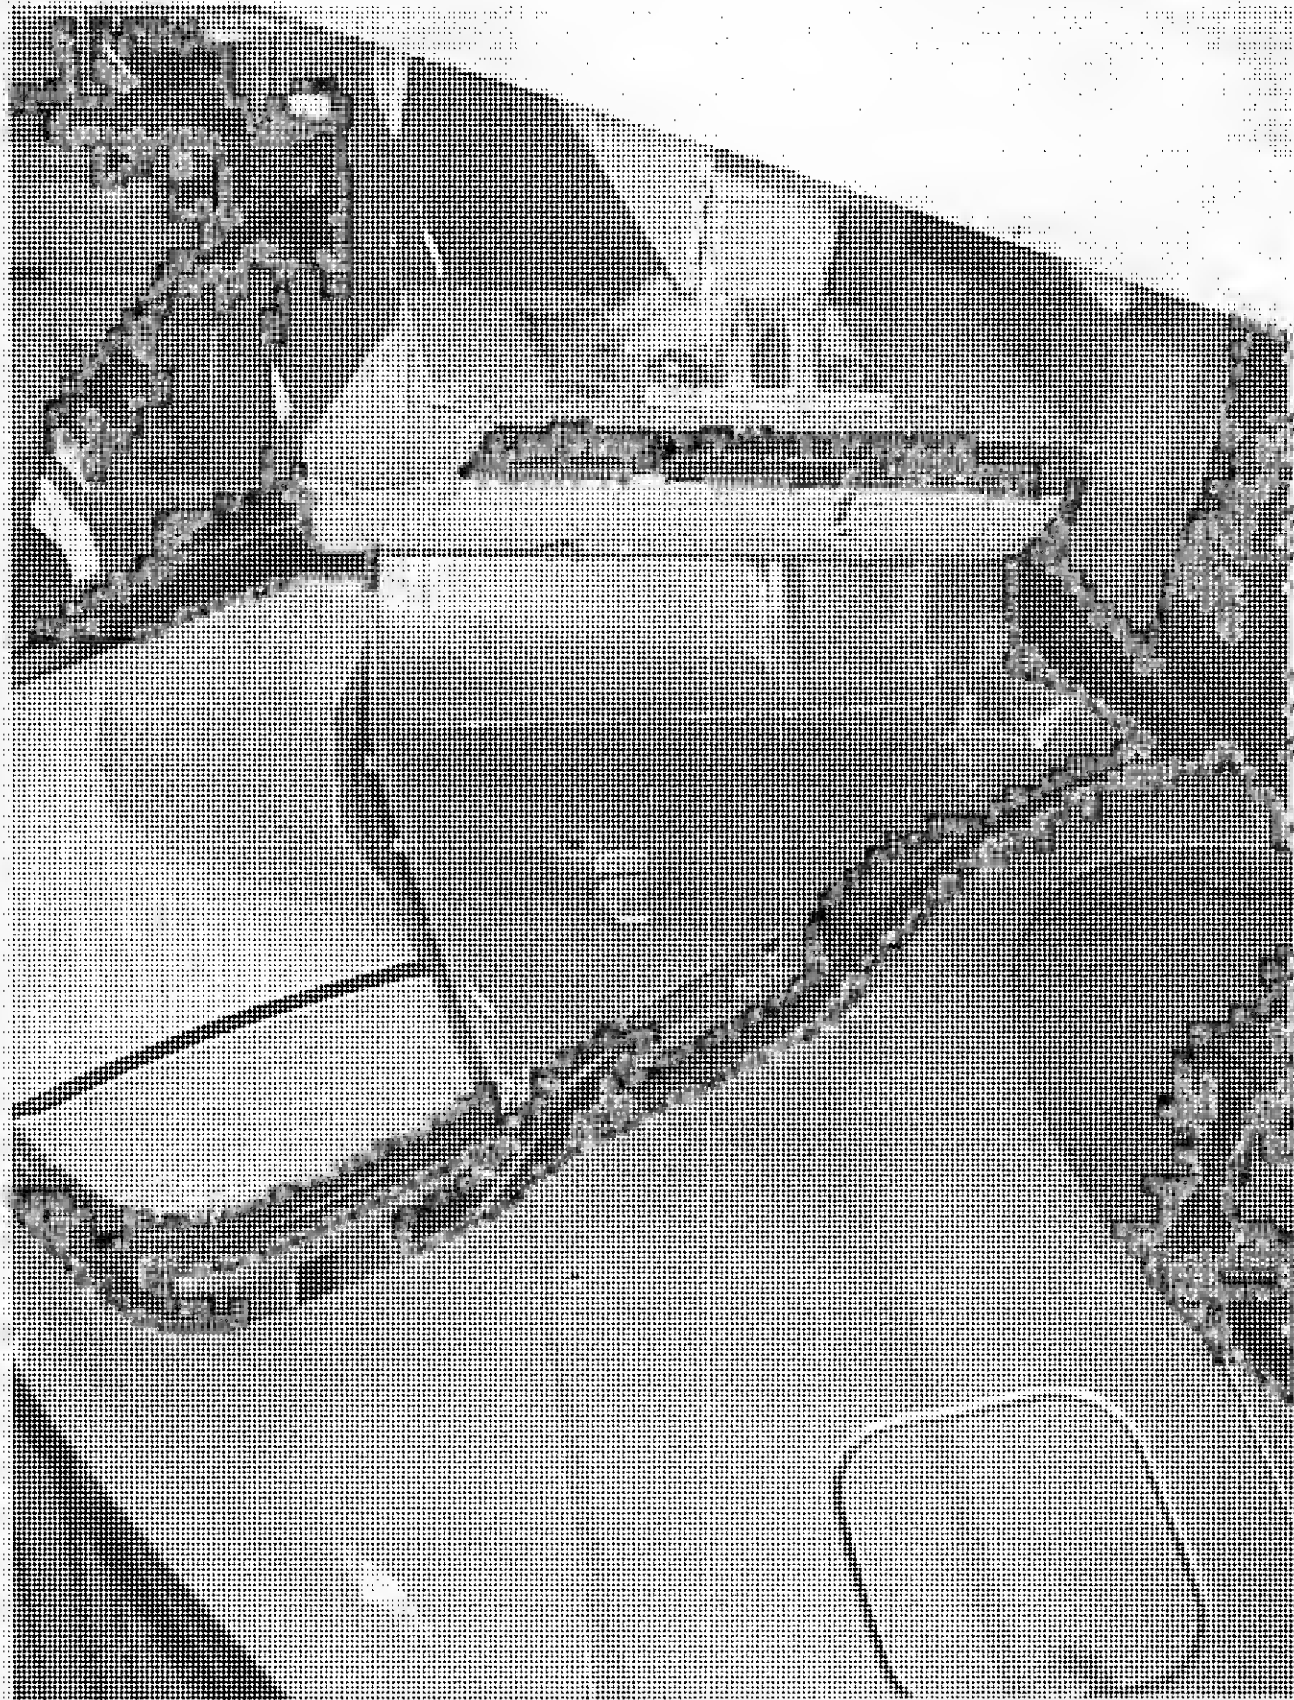
FIGURE 5.29  
POST TEST DOOR OUTSIDE - TEST 2

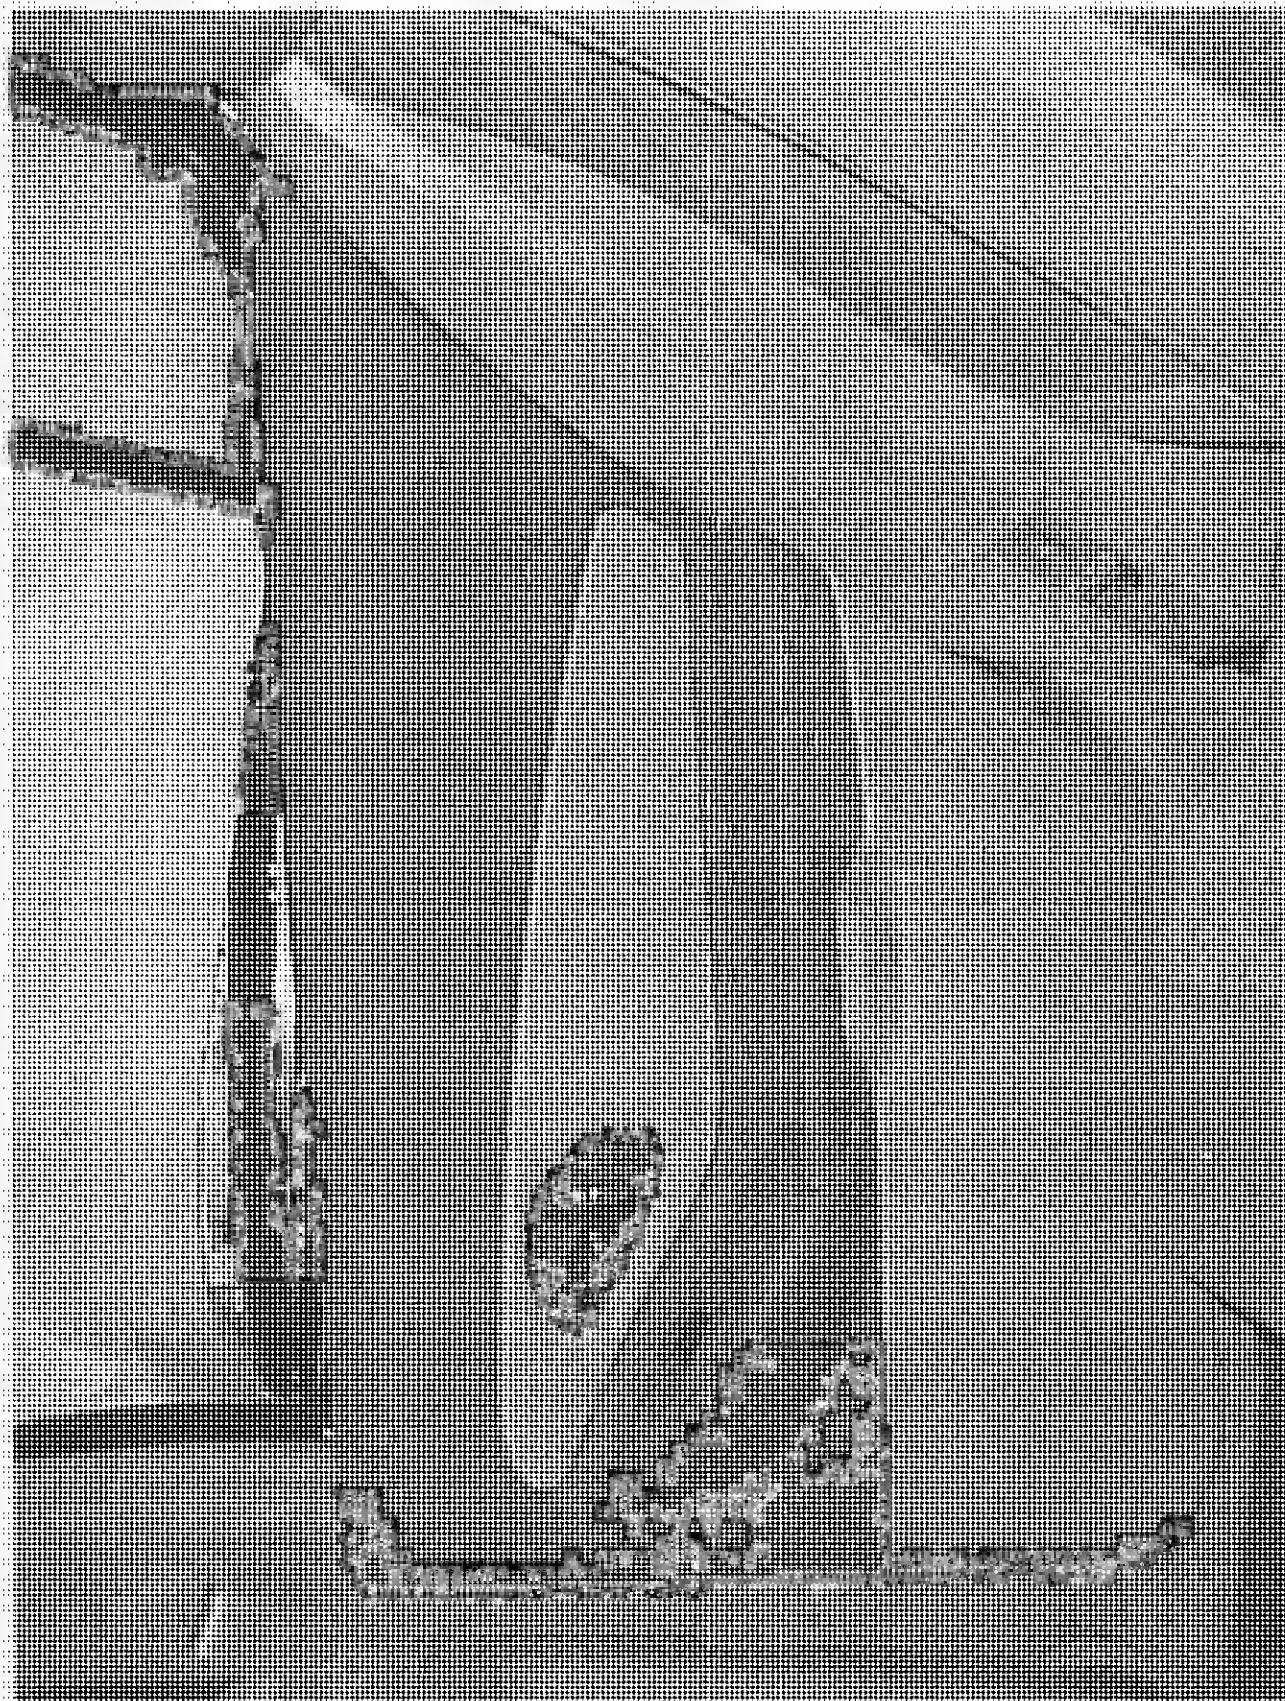
FIGURE 5.30  
POST TEST DOOR INSIDE - TEST 2

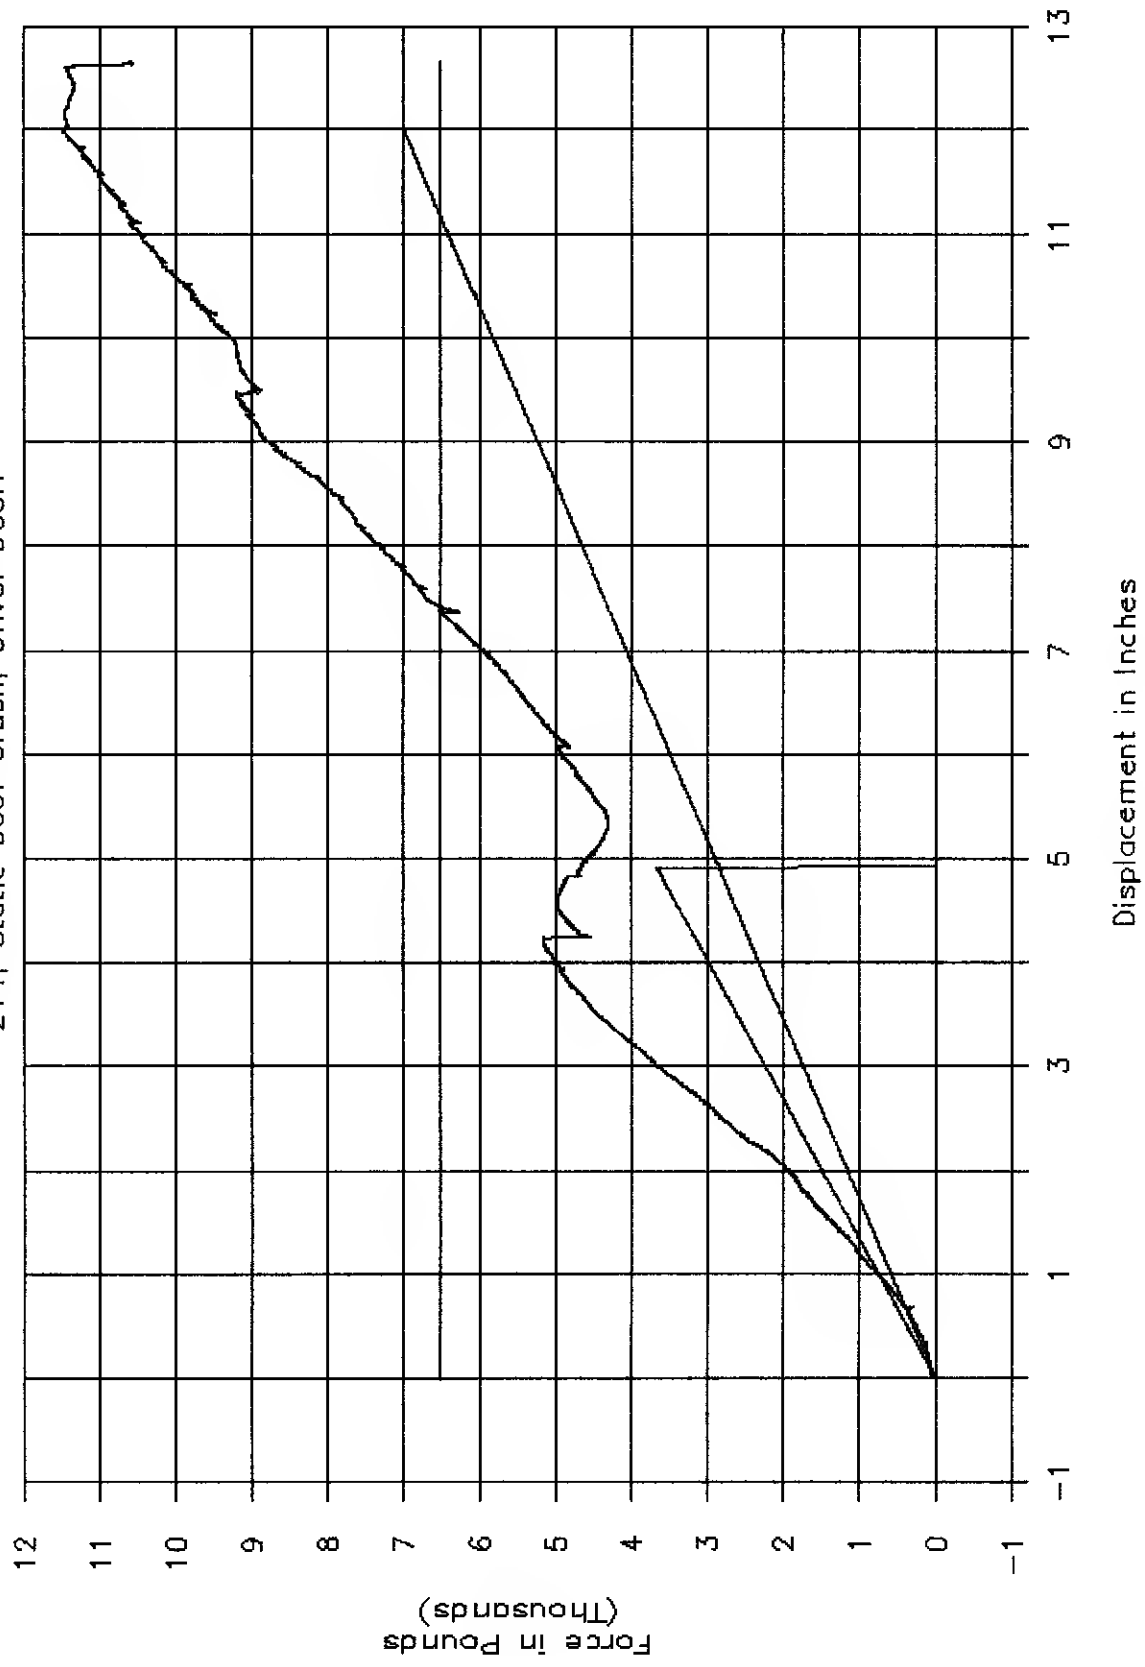
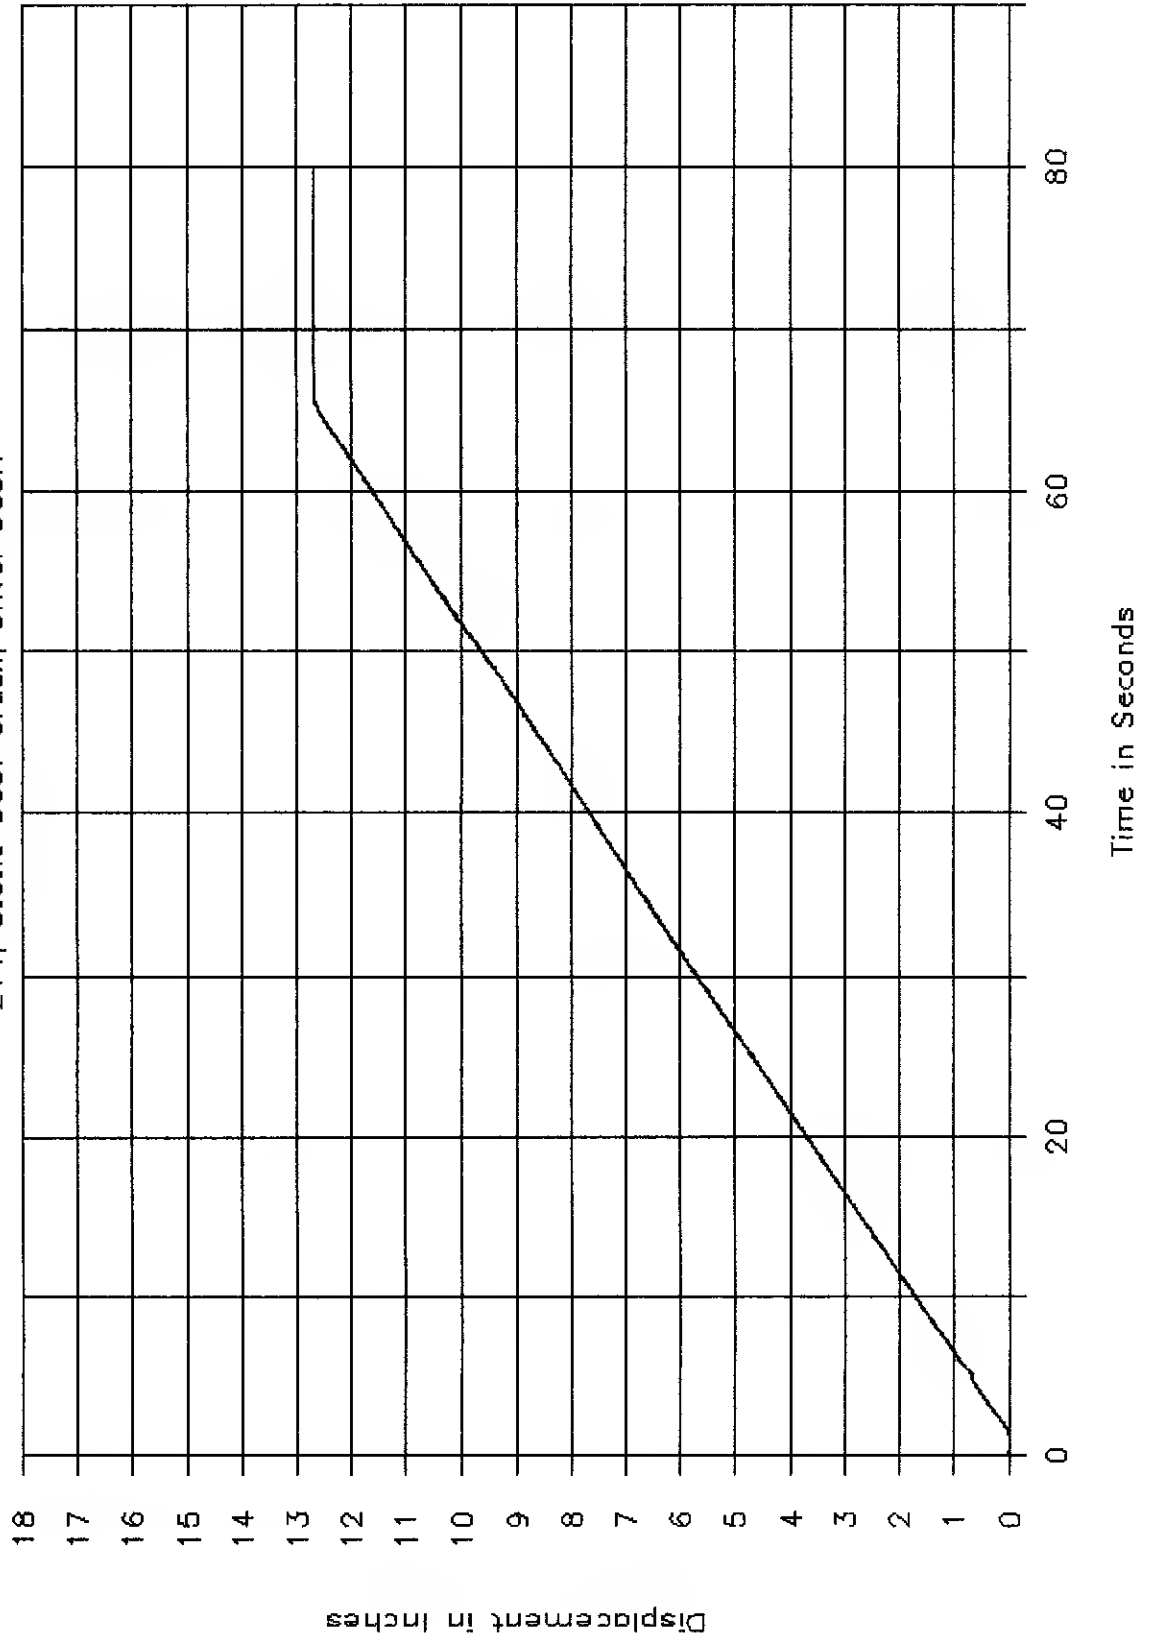
GTL 5246, NHTSA C40102.

214, Static Door Crush, Driver Door.

# GTL 5246, NHTSA C40102.

- A. The initial crush resistance was 3059 lbs.
- B. The intermediate crush resistance was 5697 lbs.
- C. The peak crush resistance was 11,495 lbs at 12.003 inches

The rate of loading was .2"/sec

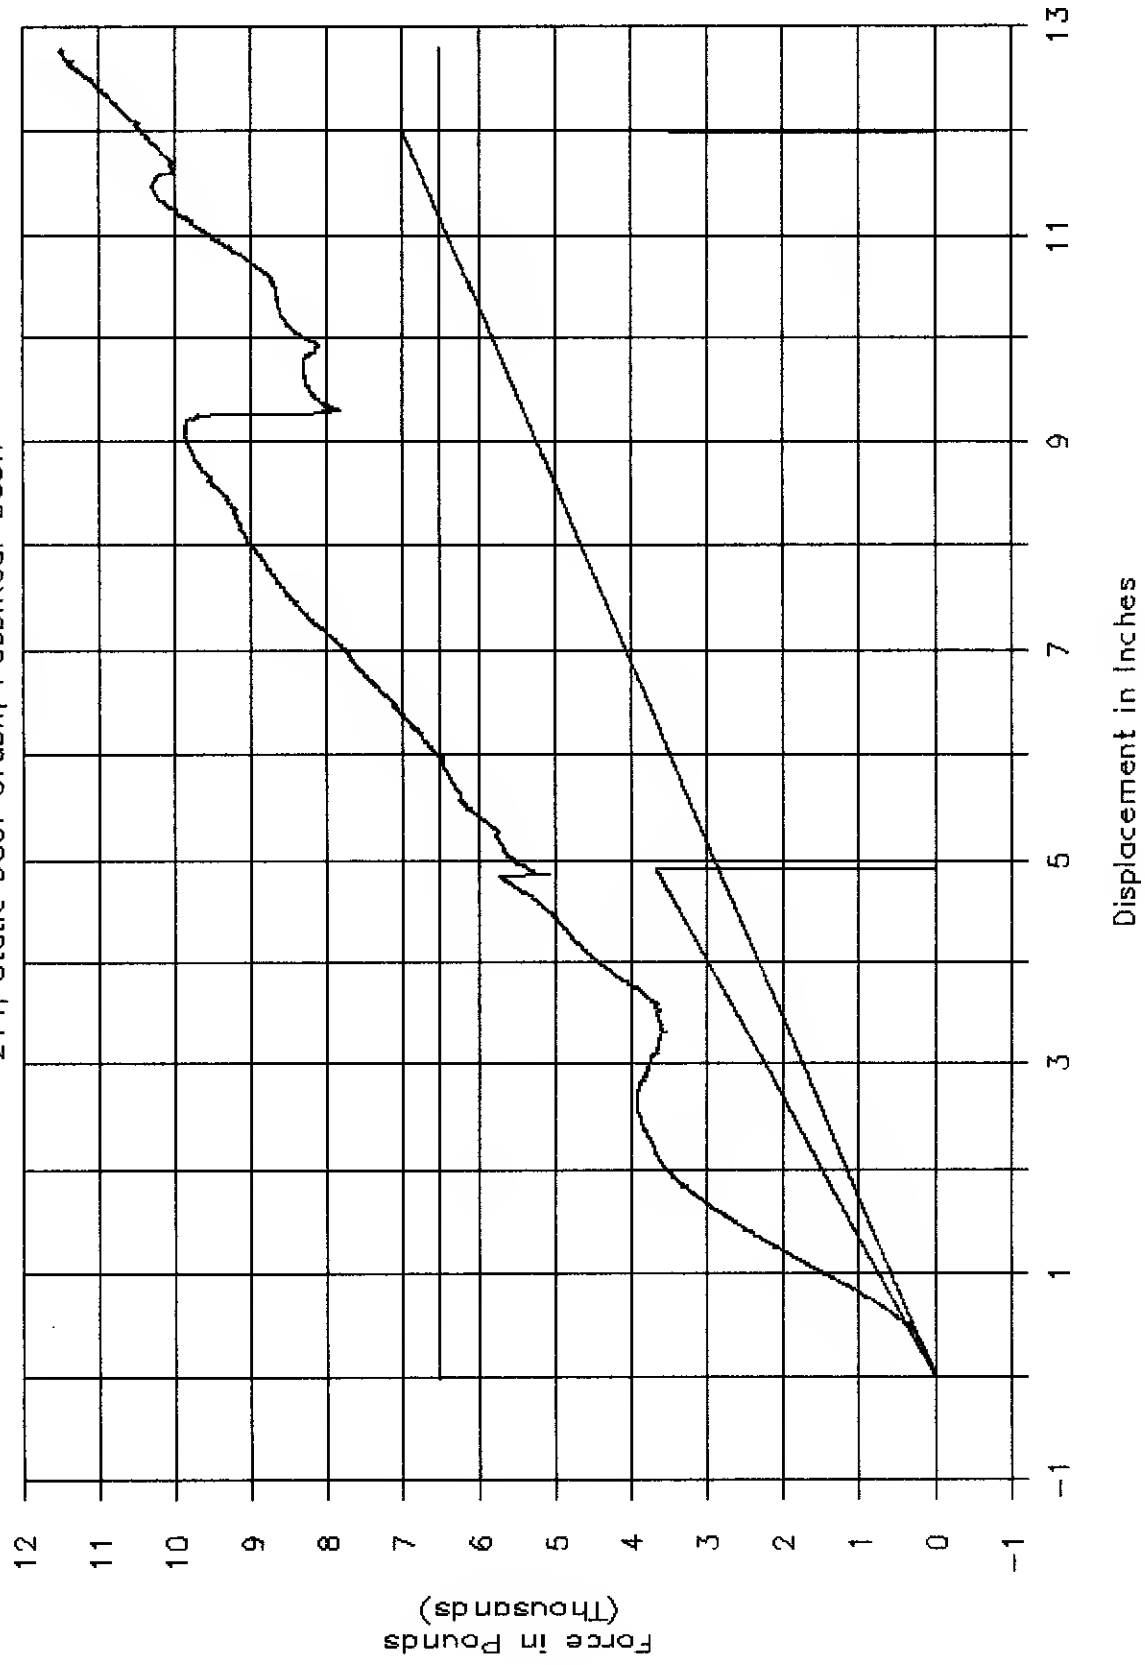
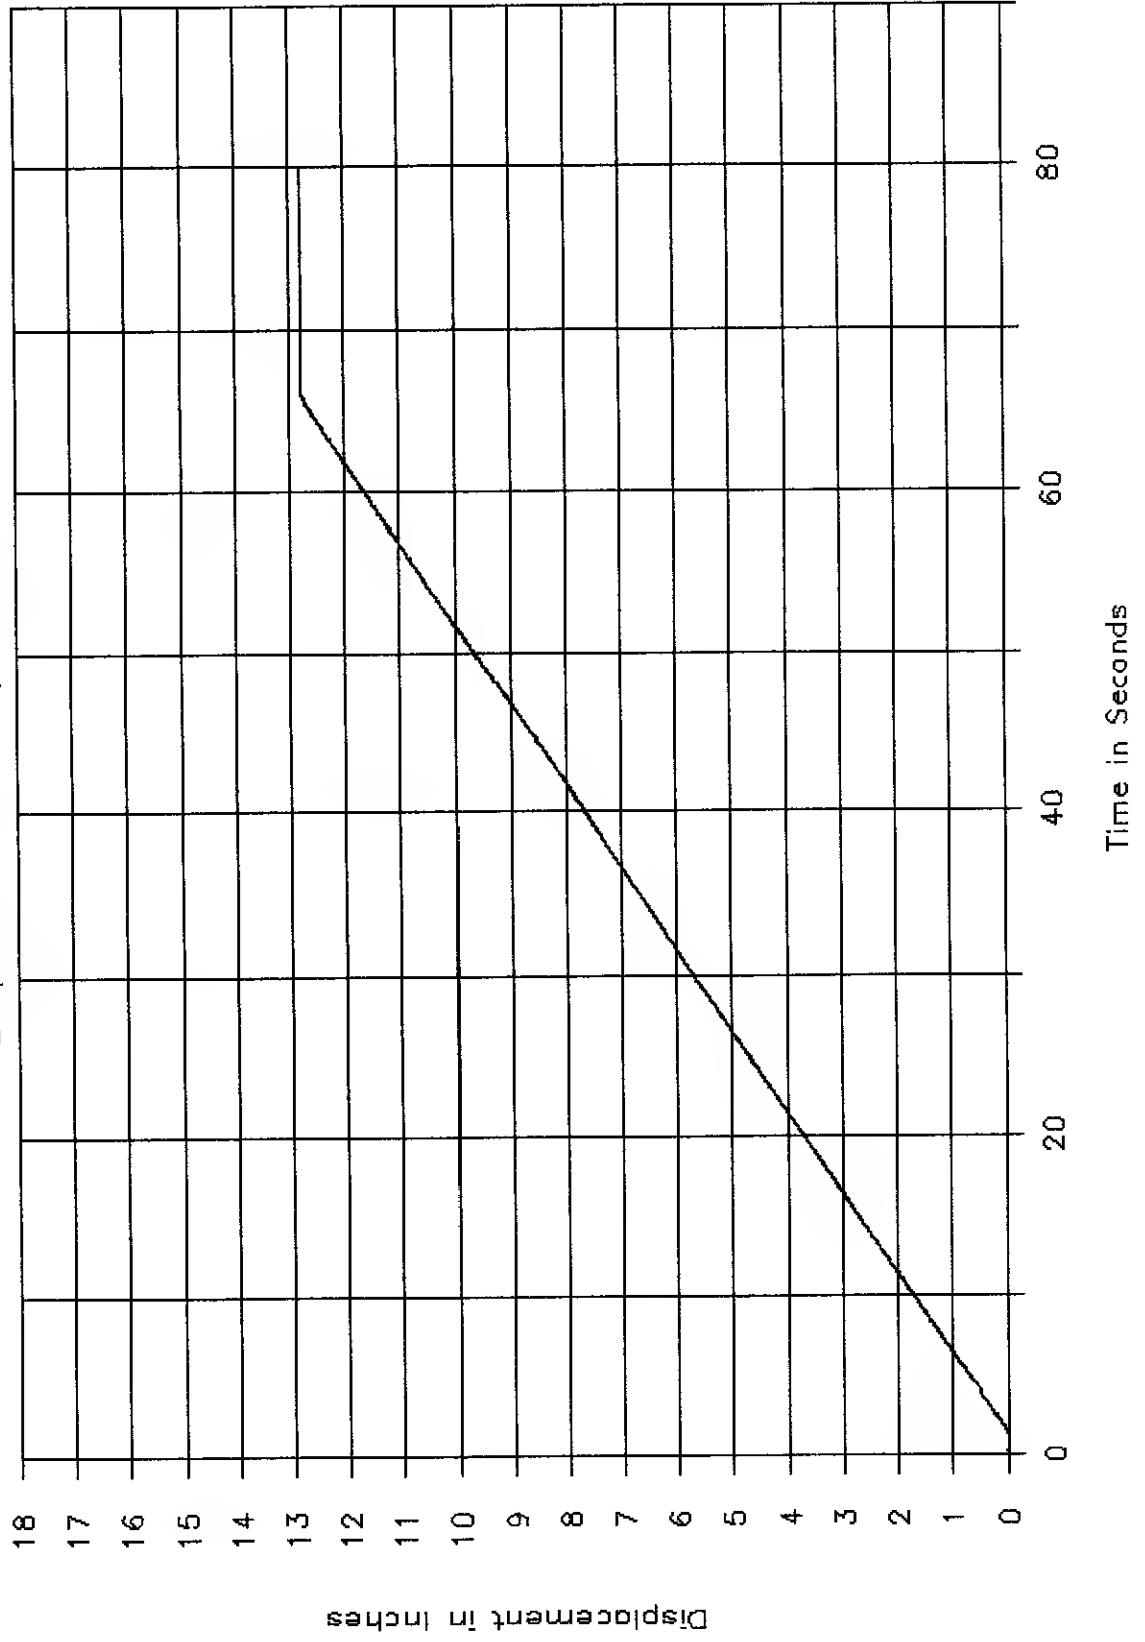
GTL 5247, NHTSA C40102.

214, Static Door Crush, Pass.Rear Door.

- A. The initial crush resistance was 3674 lbs.
- B. The intermediate crush resistance was 6211 lbs.
- C. The peak crush resistance was 11,509 lbs at 12.761 inches

The rate of loading was .2"/sec
